Art Conservation *and aging technologies*

ARTC Spotlight—August 2018

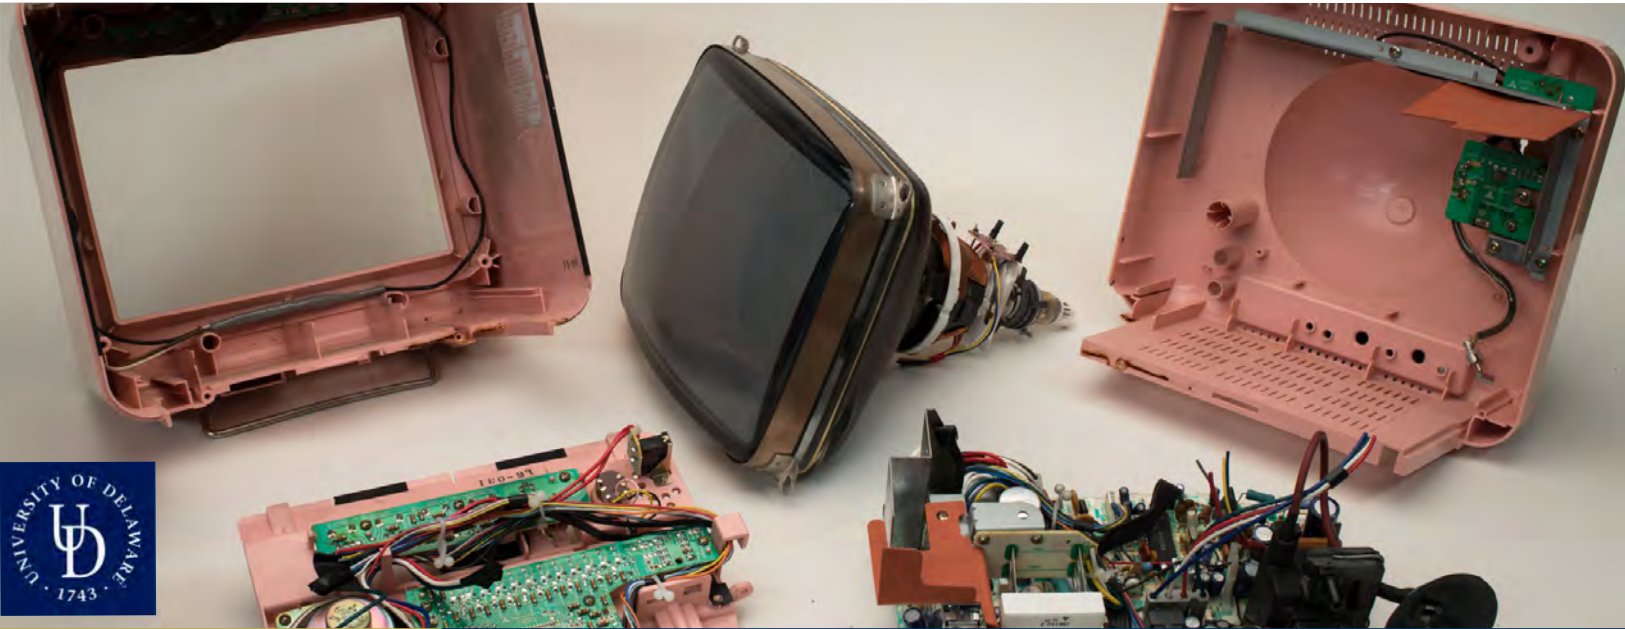
Top: Disassembled 1985 Quasar™ CRT Monitor prior to the examination of its printed circuit boards and internal components. Above: WUDPAC Fellow Nick Kaplan discharging the high voltage of the CRT in preparation for disassembly and examination. Right, top down: Detail of black accretions found on at the solders connections connections of the monitor's high voltage board and detail of flux residue found at soldered connections (10x magnification), and SEM-EDS X-ray spectra indicating the presence of elements at the soldered through hole. (Photos: Nick Kaplan, Haddon Dine, Dr. Judy Rudolph.)

Nick also found a brown, brittle, solid present on the circuit boards, which he identified as abietic acid, a principle constituent of pine rosin. Nick believes that this is explained by the use of pine-rosin flux, which would have been applied to electrical connections prior to soldering. At relatively low temperatures, pine-rosin melts into a viscous liquid. Nick found black accretions in the solidified flux that were identified as carbonized dust, which likely collected in the liquid rosin, burned, and now threaten to cause electrical shorts in nearby components. With the completion of his study, Nick hopes the issues he has identified will inform preventive strategies and help those conservators who must monitor and manage the changes TBM artworks undergo through every step of their lifecycle.
