Art Conservation *and working together*

ARTC Spotlight—September 2013

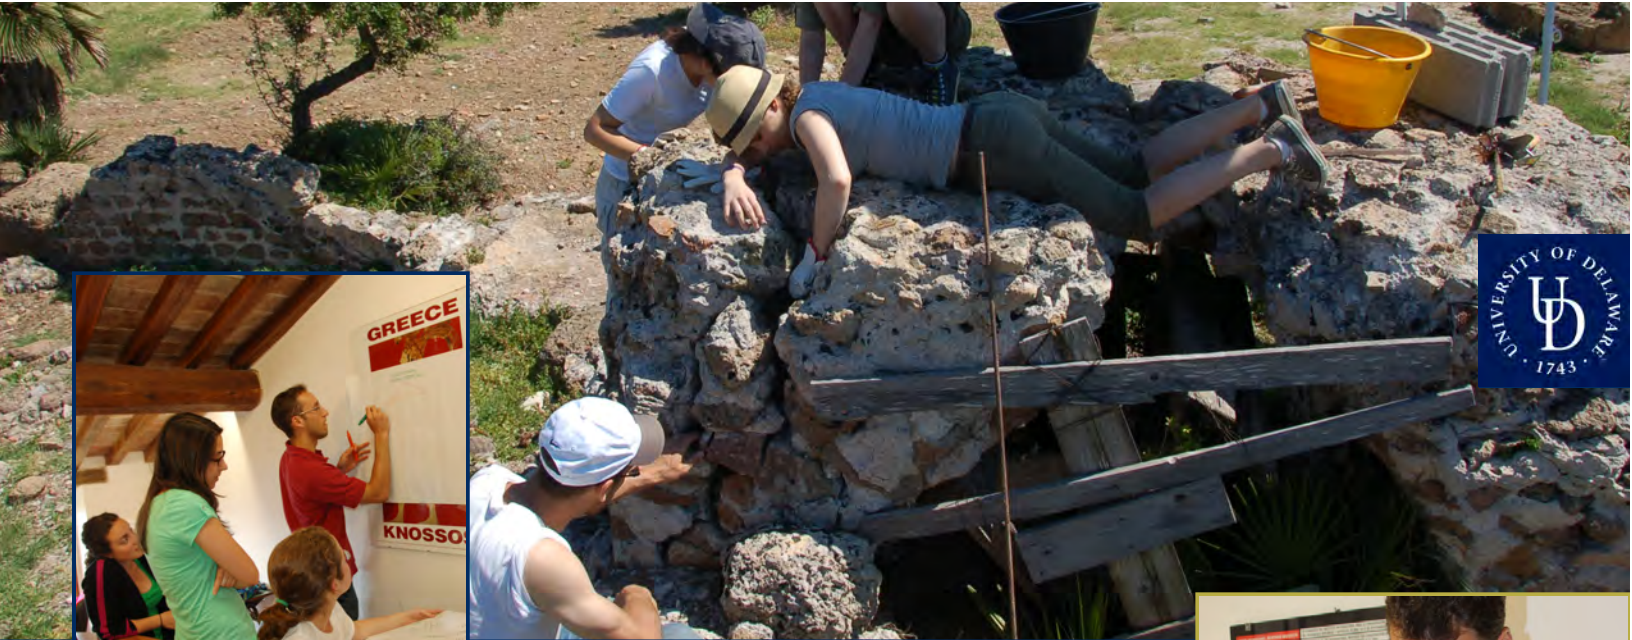
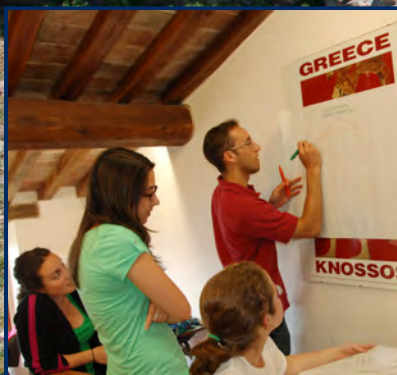
Top: WUDPAC Fellow Nick Pedemonti and a team of UD undergraduate students inspecting joints at the Roman vault; Inset: The UD team organizes their findings. Above: Nick wraps fragments of fresco in poultice to weaken calcareous deposits and encrustations; Inset: Part of the Roman ceiling fresco during treatment. Left: A fragmented section of the ceiling fresco being prepared for mortar consolidation, and a schematic of the fragmented fresco. Photos: Maria Giovanna Perrottu (above) and Centro di Conservazione Archeologica.

While at the villa, Nick was able to put his masonry skills to use as he spent two days applying mortar to a crack in a Roman vault. The mortar Nick used, similar to that in use when the vault was built, was prepared by mixing naturally hydraulic lime, lime putty, sand, and water with crushed and pulverized terracotta produced and found at the site. Nick also used traditional application techniques by adding broken fragments of local terracotta to bulk and stabilize the thick mortar joint to prevent cracking during the curing process.
